NDE SYSTEM FOR DETERMINING WOOD GUARDRAIL POST INTEGRITY

FINAL PROJECT REPORT

Washington State University

Sponsorship PacTrans and WSDOT

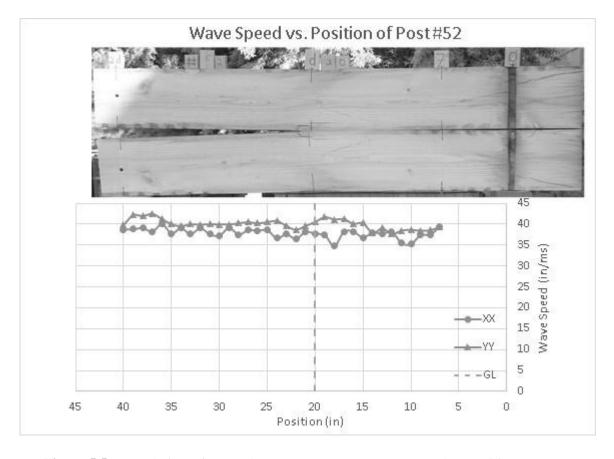
Figure 5.5 Internal view of a sound post (post #52) over wave speed vs. position

Figures 5.1 to 5.6 suggest that visual inspection is not adequate for gauging internal decay. In fact, post #58, which had severe internal decay and extremely low stress wave speeds, showed little to no exterior signs of decay. This lack of external decay indicators emphasizes the need for more rigorous NDT inspection procedures to estimate the true internal condition of wood guardrail posts.

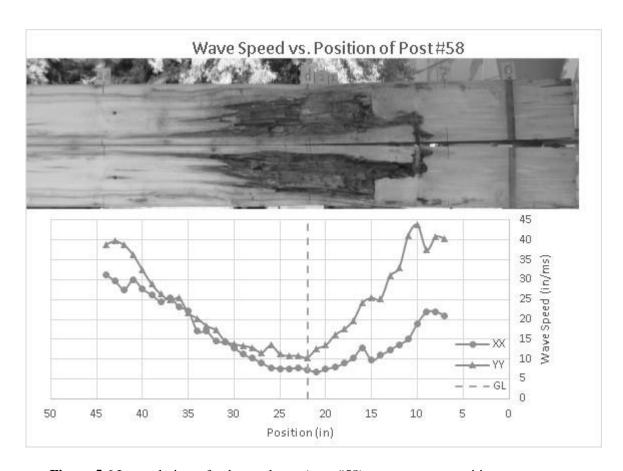
Figure 5.6 Internal view of a decayed post (post #58) over wave vs. position
